# Residential Roofing Safety

Draft 4 8 2023

John Newquist

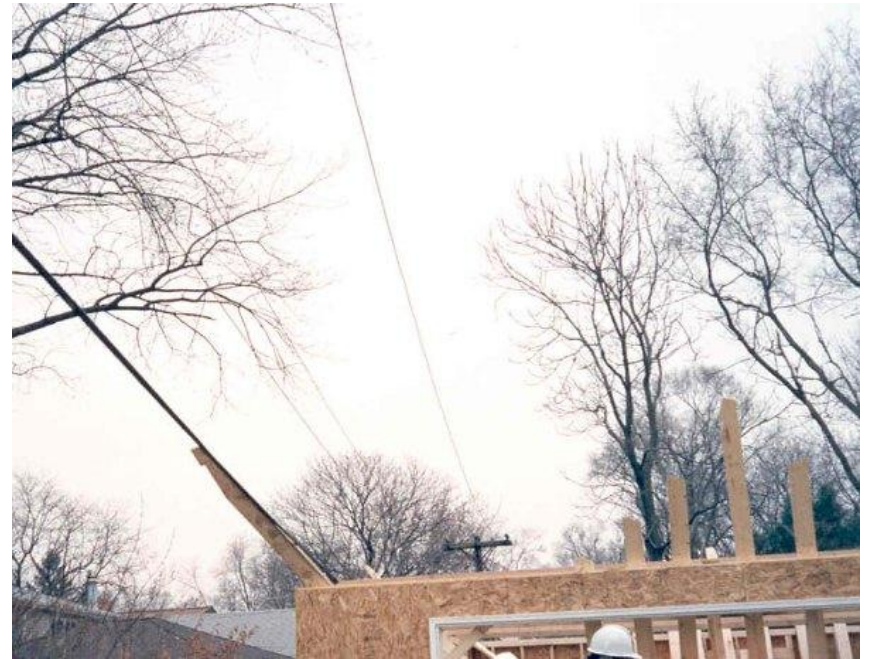
10 feet away is required.

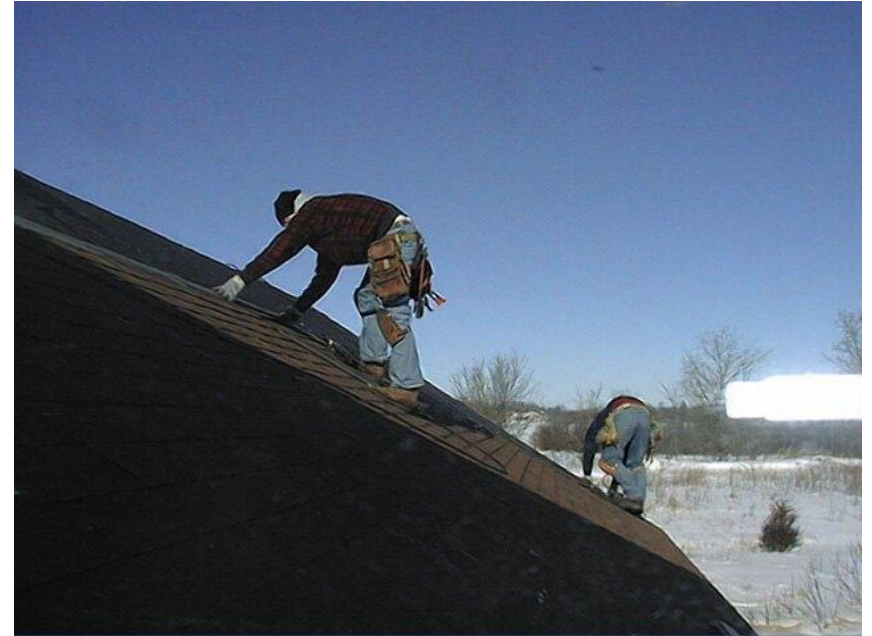
No slide protection used

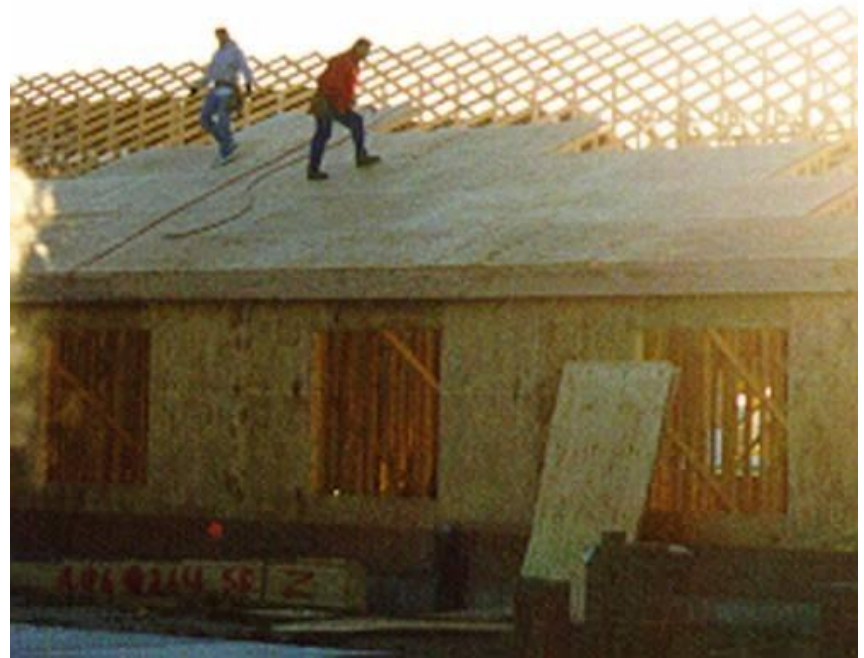
No slide guards used

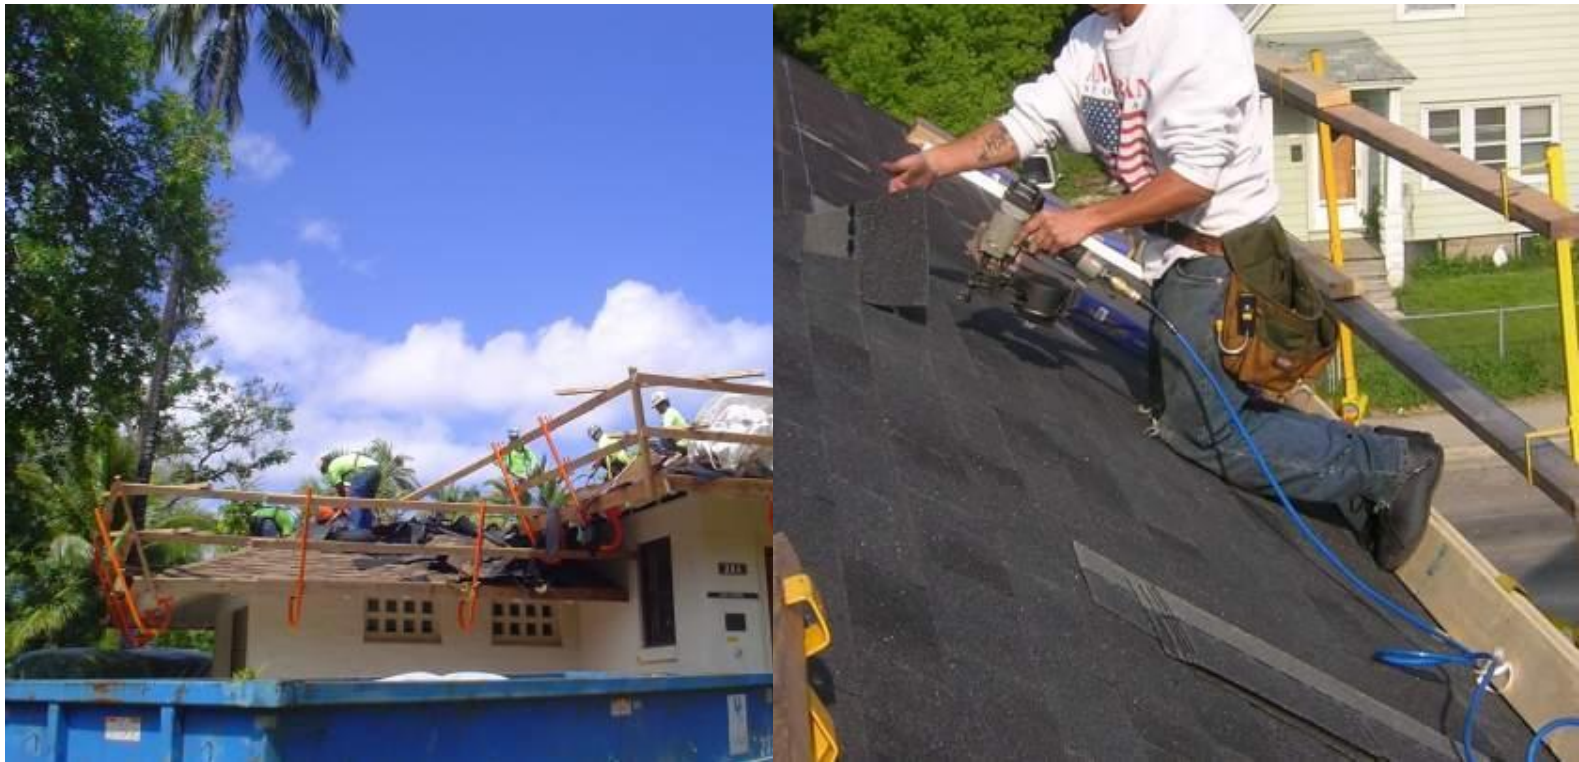
Guardrails in place during re-roofing activities.

Note: The picture on the right lacks protection for the rake edge so some means of protecting this worker (guardrail, safety nets or PFAS) must be used.

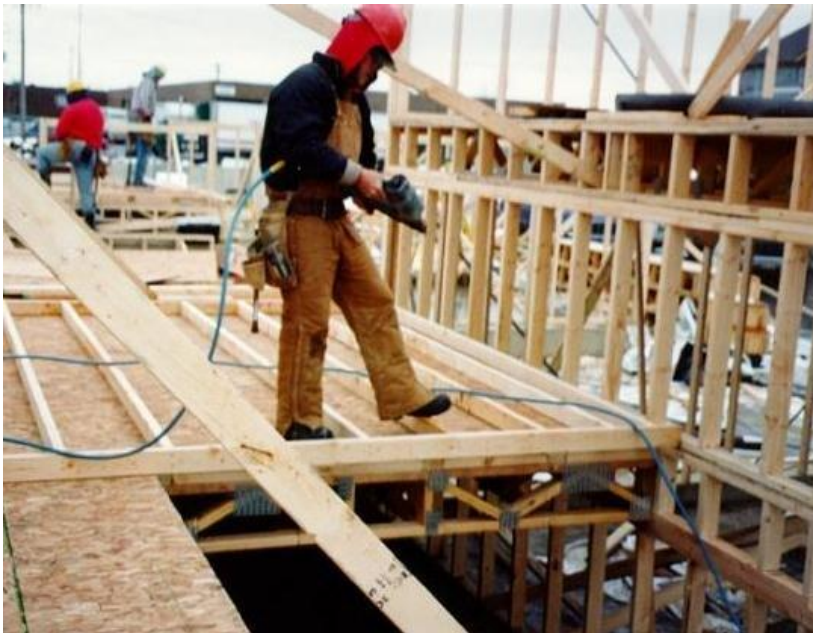
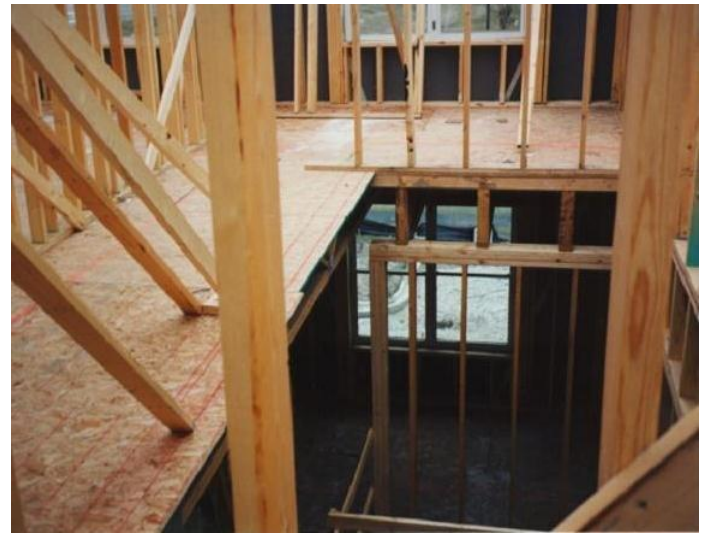
Violation: Floor opening with no guardrails.

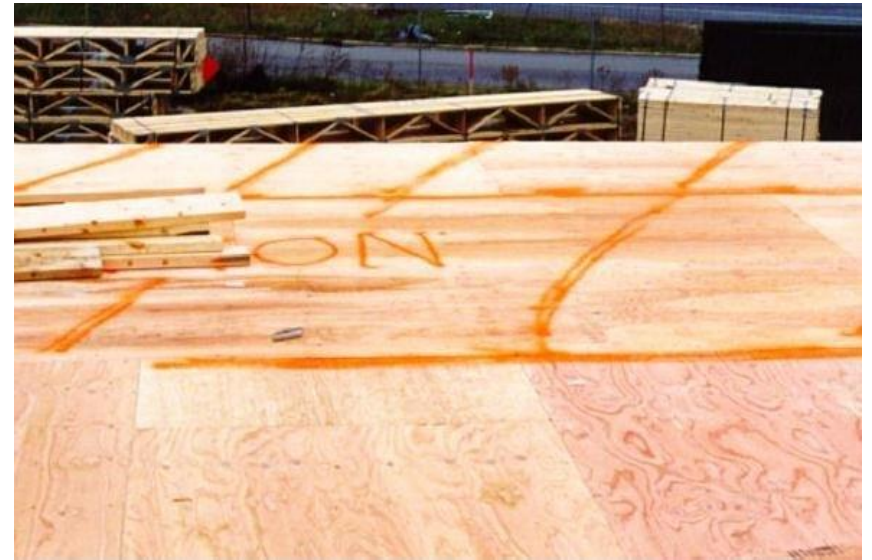
No Violation: Area for wall building marked off six feet from edge.

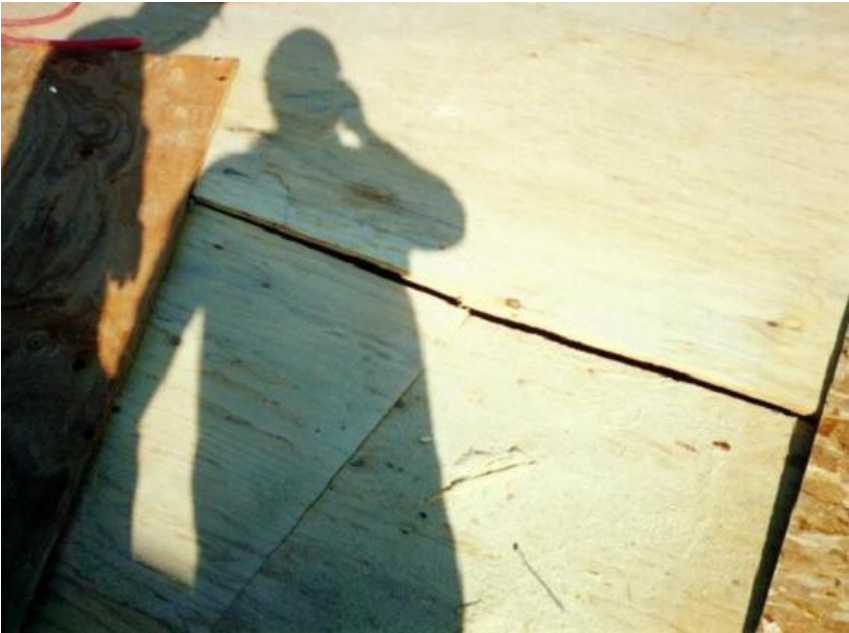
Violation: 4' x 8' sheets of plywood covering a stairway opening to the basement of a house. Only four nails hold the two covers. The cover is not marked.

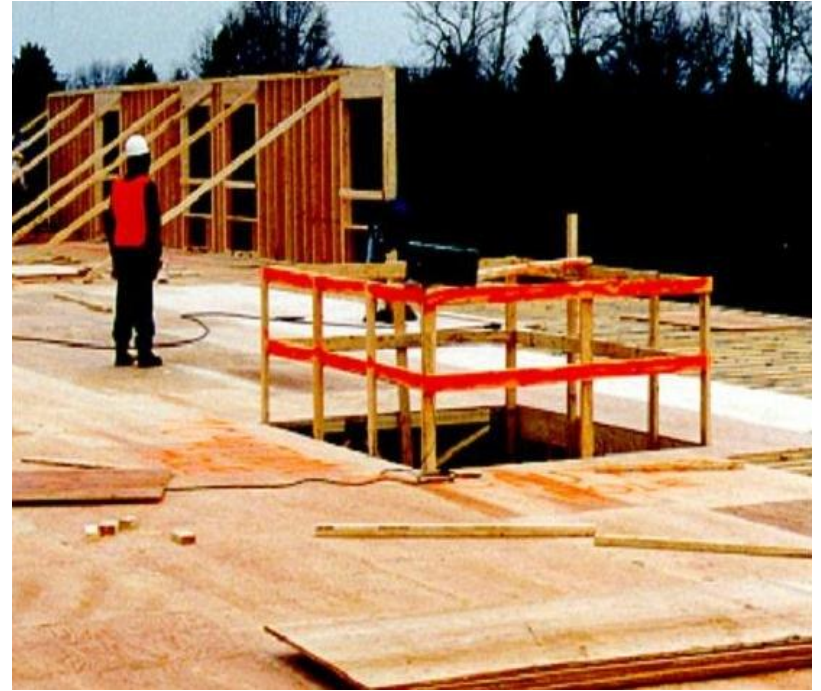
No Violation: Guardrails used

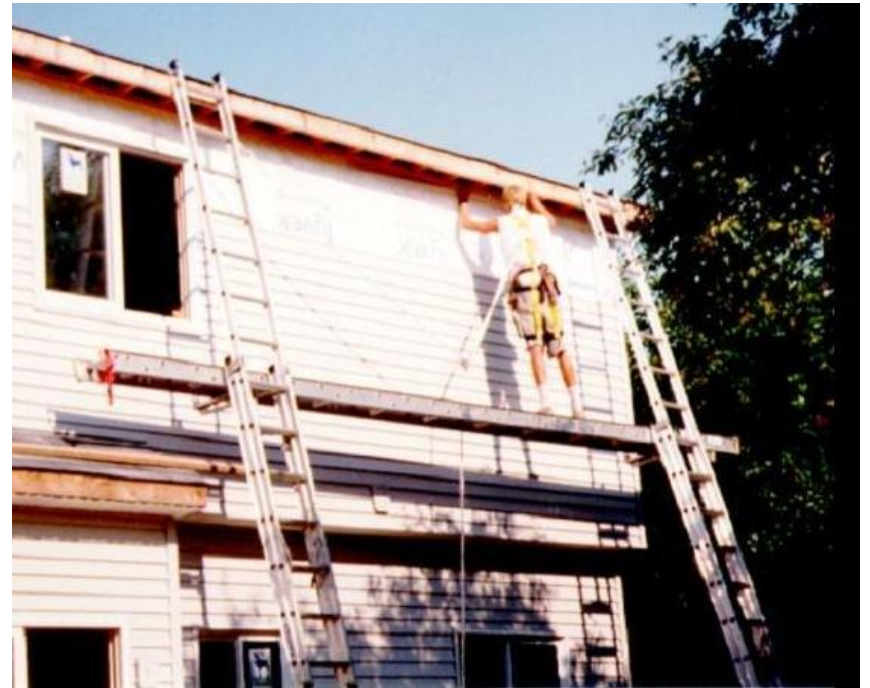
- Fall arrest is often a roof anchorage, rope grab, and body harness.

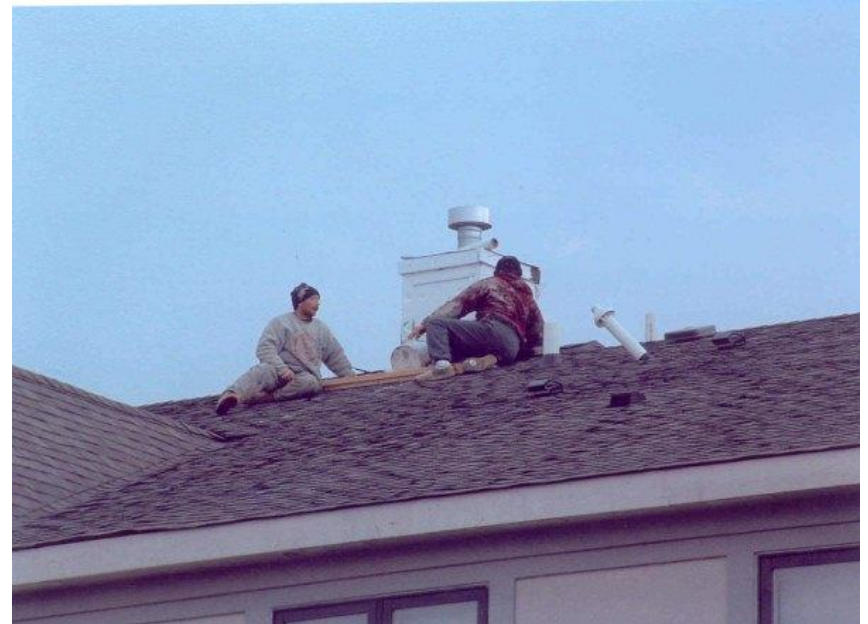
No slide guard or fall protection used

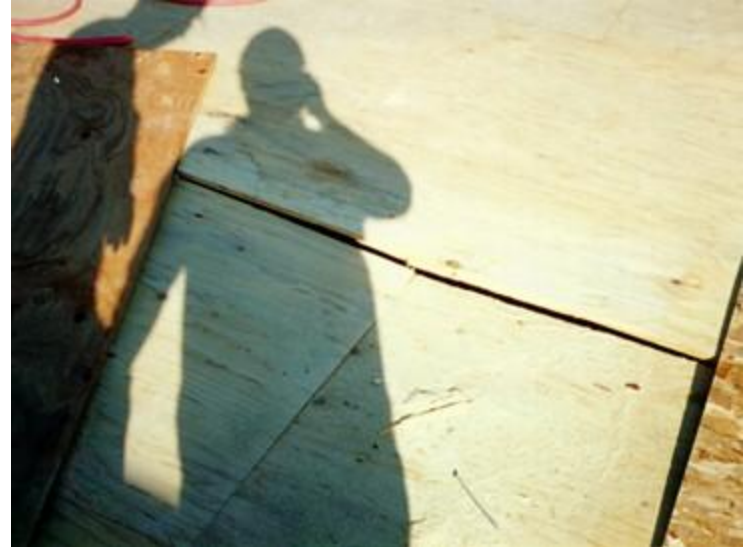
- Hold twice the weight
- Secured
- Marked

Violation: 4' x 8' sheets of plywood covering a stairway opening to the basement of a house. Only four nails hold the two covers. The cover is not marked.

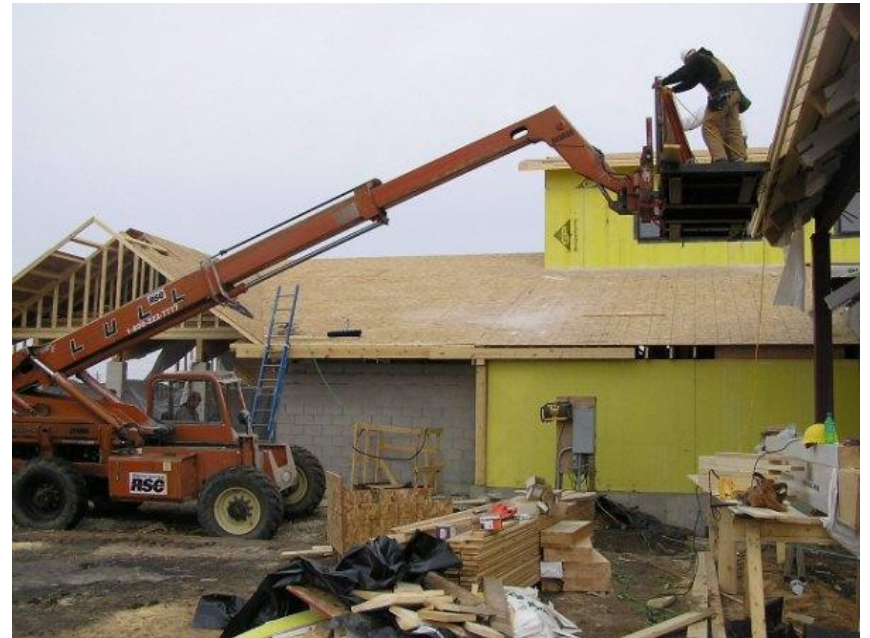
Working on a pallet is very dangerous.

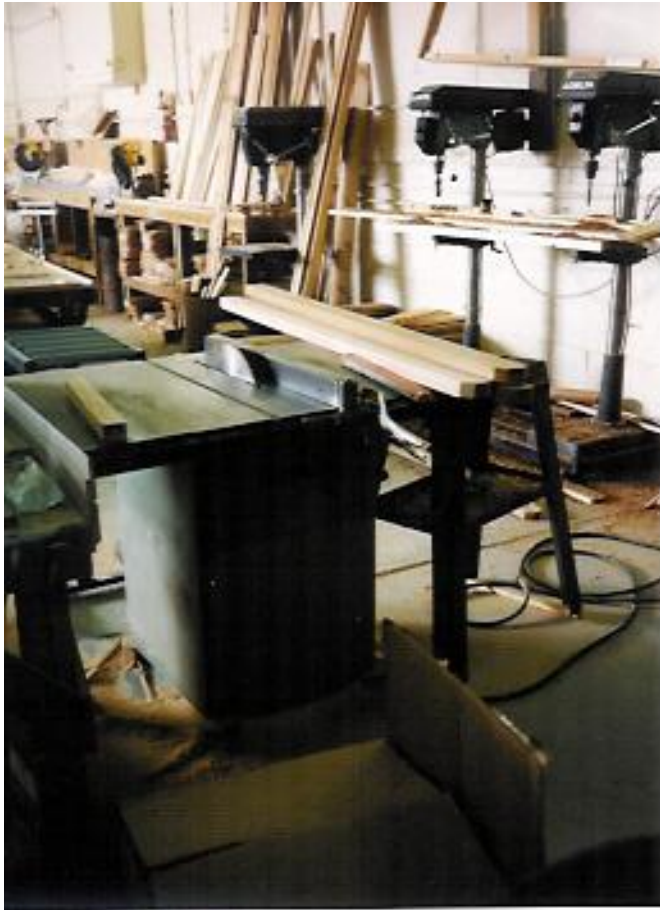
□ Unguarded table saws.

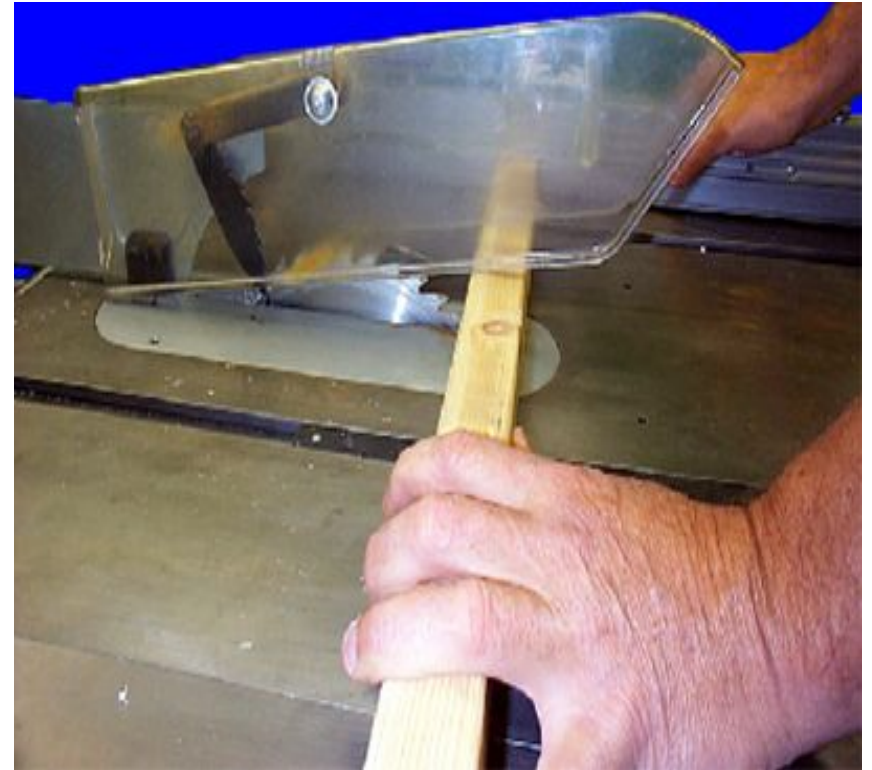
□ Guarded table saw.

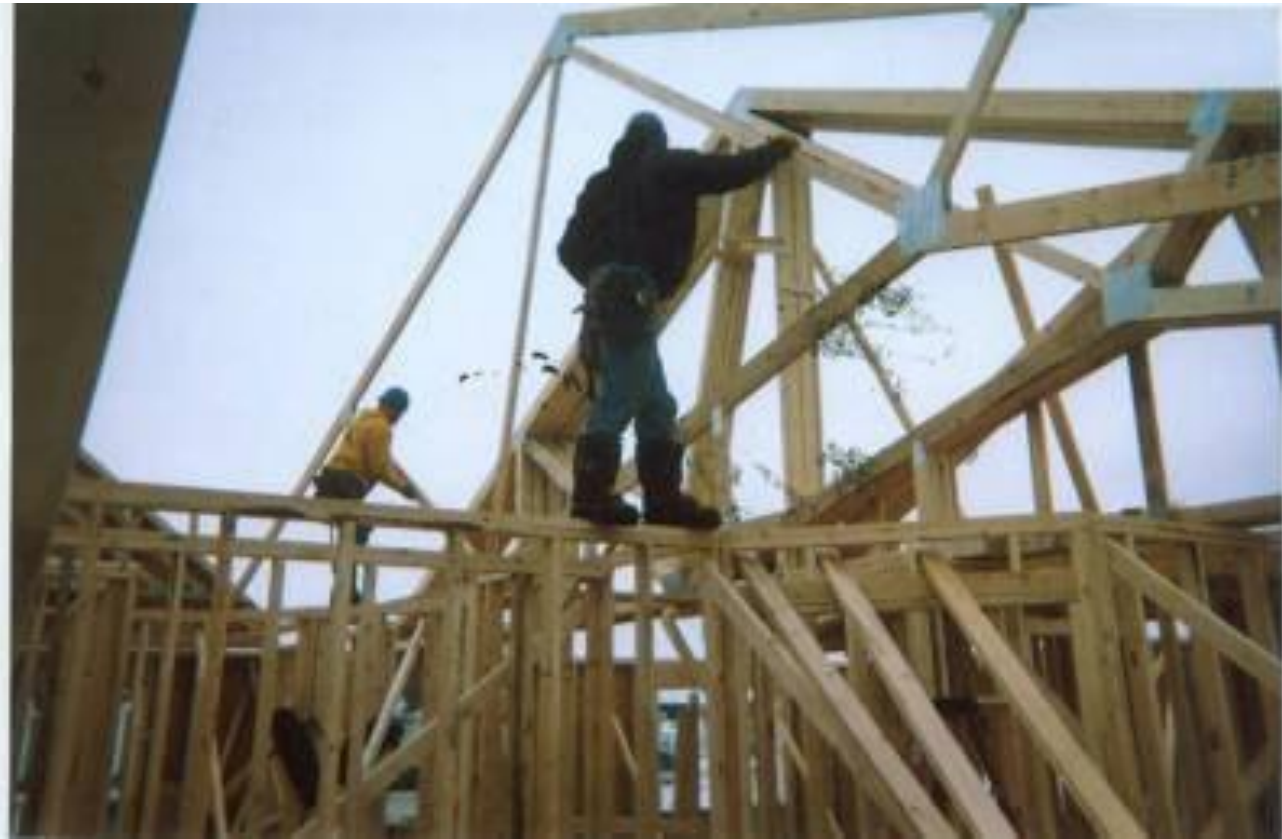
- The worker has to get on the top plate to give leverage and assist the center man with the large truss.

Due to the many configurations of residential designs it will be evaluated on a case by case basis.
